CS-APC-2

Bulletin No.: CS-APC-2-S001

Subject: ERROR 35 Cause and Repair

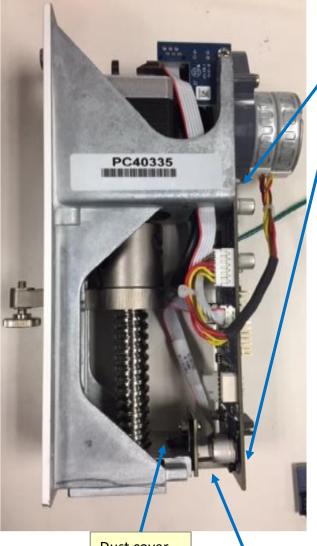
Mounting Screws For the Motor Control PCB

Fluid contaminants pooling at the base of the syringe housing will eventually lead to the contamination of the opto-detector PCB and cause a syringe drive error. The error will be reported either as error "25 – Syringe Pump Stall" or error "35 - Missing Syringe Pump Encoder" and typically requires the replacement of the optodetector PCB to restore drive functionality. If the opto-detector board has only been contaminated with oil it is often possible to clean the surface of the black slotted optoswitch on the PCB and restore the required level of optical sensitivity. To clean the opto-switch it should be sprayed with heptane and wiped with a tissue and must never be submerged in the solvent.

The optical detector PCB is located on the drive as shown. The PCB is mounted to the drive frame with the stand-off that provides the mounting for the motor drive board. It is also mounted to the metal dust cover plate that protects the encoder wheel.

- 1. Remove the two mounting screws for the Motor control board.
- 2. The motor control board can be moved sideways with all the cables still plugged in to gain access to the optical detector circuit board, or the cables can be unplugged from the control board so it can be removed completely out of the way. (Note where the cable plug in if the board is completely removed so they can be put back in the correct sockets).
- 3. Unplug the grey ribbon cable from the optical sensor PCB.
- 4. Remove the screw and nut that holds the metal dust plate to the optical detector board.
- 5. Remove the standoff to completely free the board from the drive
- 6. Spray heptane on both the source and detector surfaces of the inside of the slotted optical switch and then plow with clean air to dry.
- 7. Re-install the PCB and test the drive.
- 8. If cleaning fails then replace the PCB.
