Background

Issue

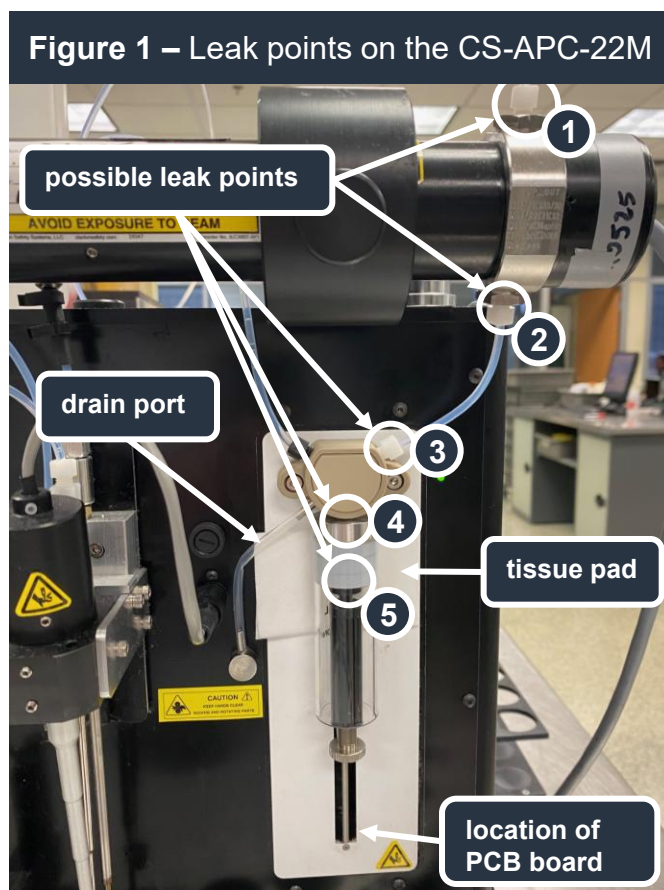
Leak Sources: Leaks occur on the positive pressure side of the sample delivery system and may originate from any of the five (5) locations shown in Figure 1.

Figure 1 – Potential leak points on the CS-APC-22M instrument, including (1), (2) and (3) ensure the tubing nuts are well “finger” tightened, (4) ensure the syringe body is well tightened (“finger” tight) into the syringe valve, and (5) replace the syringe seal if it appears worn.

Permanent Resolution: After any maintenance activity requiring their removal, ensure all tubes and tube nuts are properly secured in ports from which they were removed and make sure the syringe is firmly screwed into the bottom port of the syringe valve. Regularly inspect the bottom rim of the syringe barrel for signs of a leak and replace the syringe piston seal if a significant fluid build up is detected.
