#### Background

#### Issue

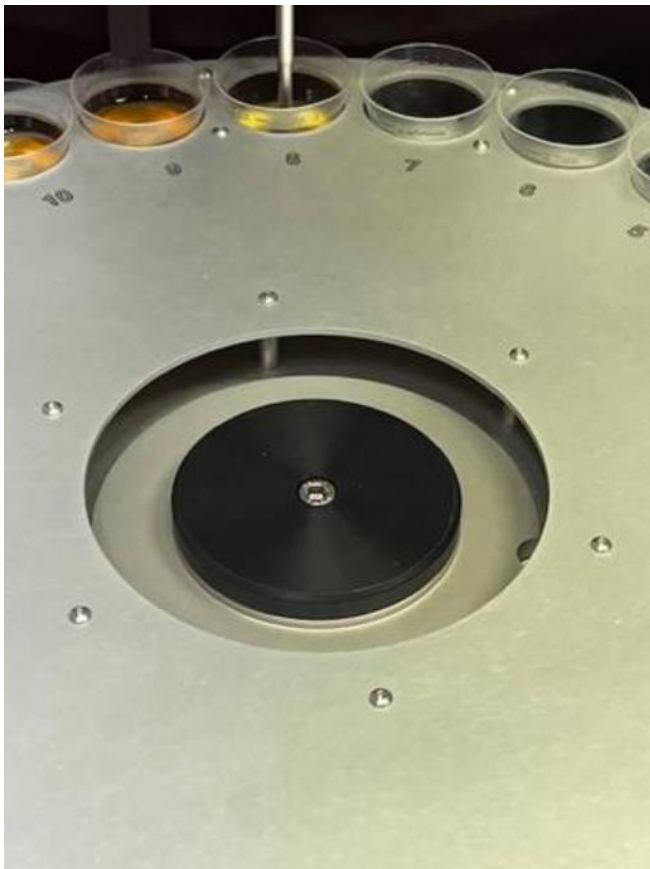
The four (4) screws that hold the metal disc to the glass may come loose during operation. This procedure addresses the proper steps to re-tighten the sample tray, and to modify the software settings to prevent the reoccurrence of the issue.

*The CINRG CS-APC-22M sample tray showing the black acetal cap/cover.*

The black acetal cap with one hex socket screw doesn't have a functional purpose. It just covers the 4x #10-32 Hex socket head screws that need to be tightened. To tighten the sample tray:

1. Remove the sample tray.
2. Using the CINRG software's testing panel, send 'Reset carousel'.
3. Once the carousel resets and is at position 1, close the software and turn off the instrument.

4. Remove the 1x metric hex socket screw holding the black acetal cap/cover.
5. Now check how tight the 4x #10-32 screws that hold the metal disc to the glass. It should neither be too tight nor be too loose. Must be finger tight (slightly more than it).

6. There is an 'o'-ring beneath the metal piece that presses against the glass while you tighten it. While you do the step 5, check if the 'o'-ring did not move from its groove (underside of the metal disc).

7. Once you reinstall/tighten the metal disc, do not install the black cap (we can install later when we confirm the issue is resolved- till then we may need access to those 4x screws)

8. Turn on power to the instrument
9. Open CINRG software and head to the testing panel. Click reset carousel. Also input several sample positions and see how the unit performs.

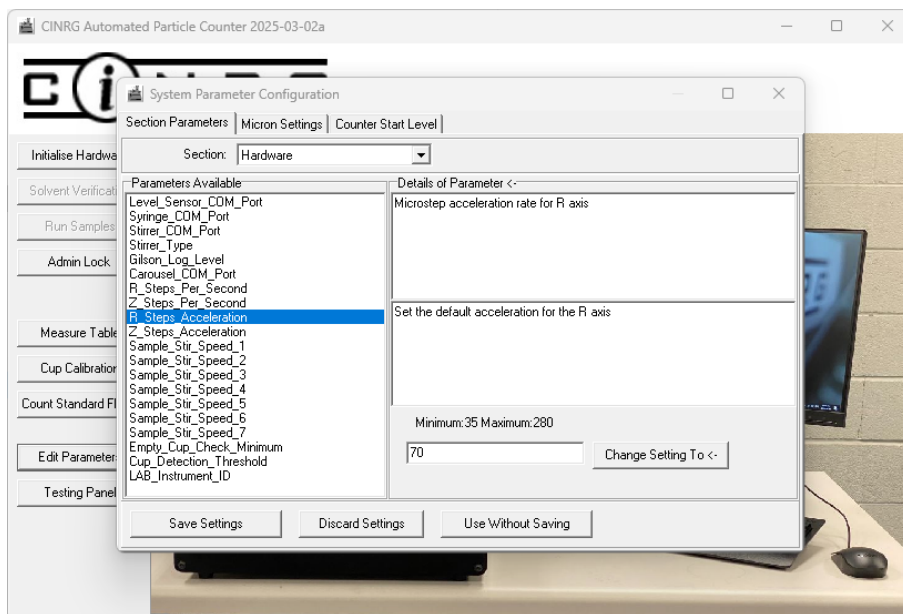
**Figure 1** – The Section Parameters tab of the Edit Parameters dialog showing the hardware settings.

If the tray is coming loose repeatedly, it may be necessary to lower the speed of the rotary drive. This can be accomplished through the CS-APC-22M instrument software.

1. Launch the instrument software in admin mode.
2. Click the [Edit Parameters] button from the admin menu.
3. From the Section Parameters tab select the Hardware section (see Figure 1).
4. Set R\_Steps\_Per\_Second to 50000.
5. Set R\_Steps\_Acceleration to 35.
6. Click Save Settings and close the System Panel Configuration dialog.

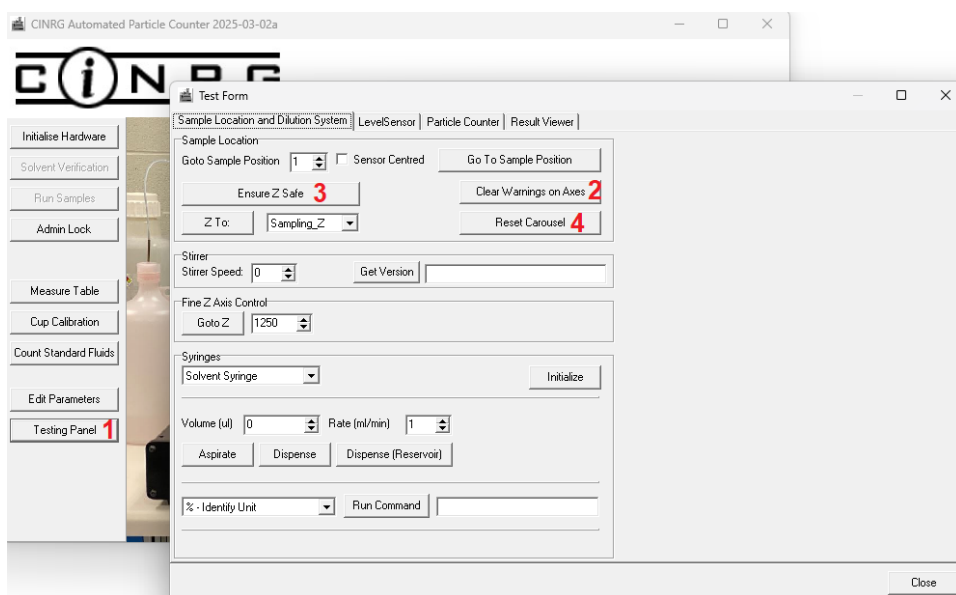
**Figure 2** – The Sample Location and Dilution System tab of the Testing Panel dialog.

You may need to perform an instrument re-set after encountering any motion related errors from Zaber 'Z' axis drive or the Rotary drive. You can use the testing panel to clear out the errors to resume operation.

1. Click on the [Testing Panel] button from the admin menu (labelled “1” in Figure 2).
2. Click on the [Clear Warnings on Axes] button (labelled “2” in Figure 2).
3. Click on the [Ensure Z Safe] button (labelled “3” in Figure 2).
4. Click on the [Reset Carousel] button (labelled “4” in Figure 2).
