Background

Error 45 occurs. This error can occur on the onboard syringe of the 215 liquid handler or the right-hand syringe of the 402 syringe pump but the trouble shooting process is the same for both units as the hardware is the same. There is however a difference in the commands that are required to drive the syringes, and this is important if the Gilson Utilities program is used to send commands to the pump. A syringe overload condition can have a variety of causes and only some of them actually cause the syringe drive to be overloaded.

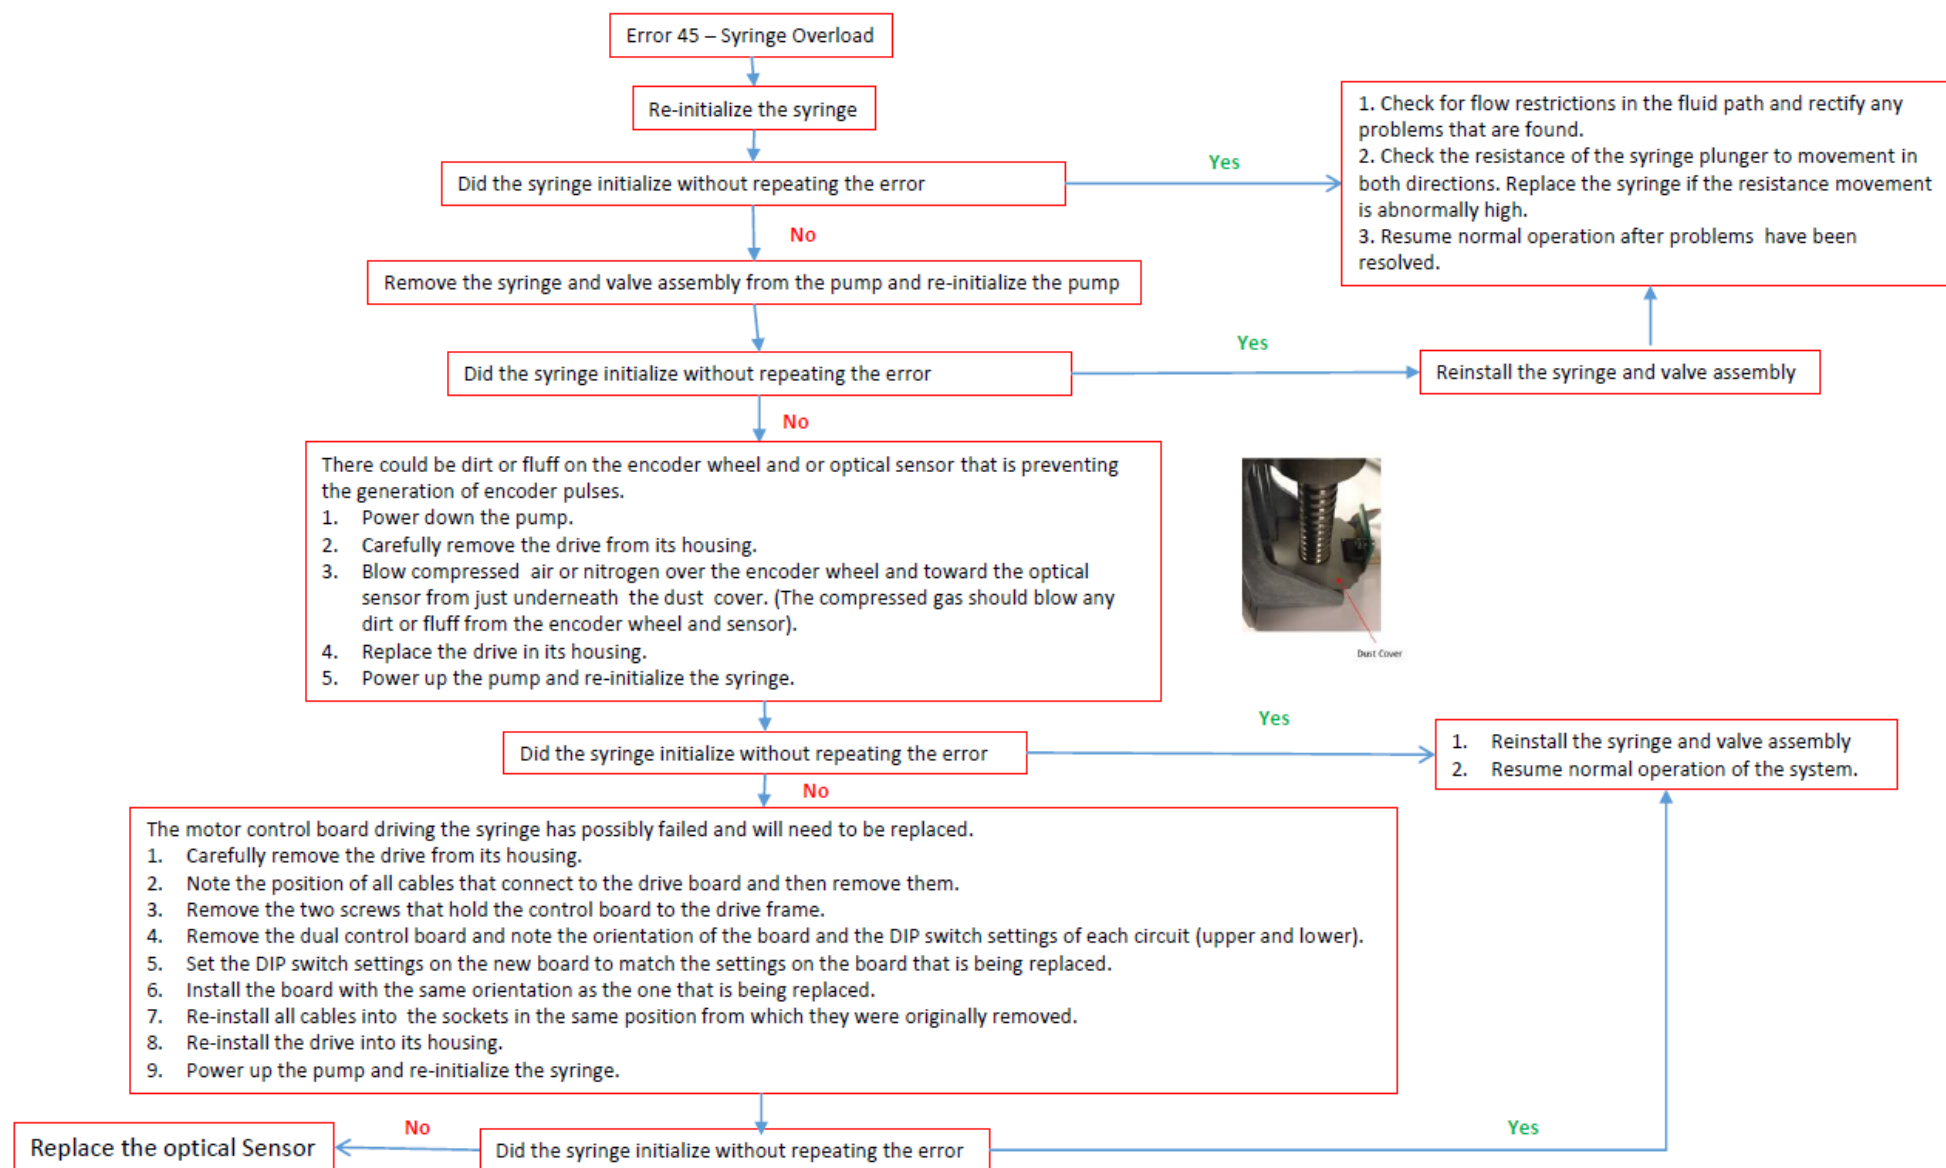
Syringe Over-load Trouble-shooting Chart

A number of issues can cause a syringe overload. Use the Syringe Overload Trouble-shooting Flow Chart on the next page to track down the source of the issue. Additionally, the trouble-shooting chart includes issue resolution instructions.

1. A flow restriction in the solvent delivery system -This causes a genuine overload condition.
2. A tight syringe plunger –Some solvents cause the syringe plunger seal to swell, and it becomes much more difficult to move the syringe plunger up and down –This also causes a genuine overload condition.

3. One or more slots of the slotted encoder wheel at the base of the ball screw of the drive have become contaminated with debris that is blocking the light from the optical sensor from passing through the slot –this causes an overload message to be generated but it is not actually a genuine overload condition.

4. The optical sensor has become contaminated to the extent that the transmitted light beam in the sensor is either blocked completely or too weak to detect the slots in the encoder wheel when it turns –this causes an overload message to be generated but it is not actually an overload condition.

5. Either the transmitter or receiver of the optical sensor has failed, and the optical sensor no longer transmits voltage pulses in response to a moving encoder wheel -this causes an overload message to be generated but is not actually an overload condition.

6. The Motor drive board has failed –this will result in a syringe overload message and most often the drive board fails as a result of a genuine overload condition that has remained unresolved while several attempts have been made to initialize the syringe. In a genuine overload condition maximum power is applied to the motor for a short time until the fault is detected. This caused a high current to pass through the power transistors of the control board, and they get hot. If repeated attempts are made to initialize the syringe drive when it is genuinely overloaded, then the transistors on the drive get too hot and one or more of them fail. they fail.
